IMCA Safety Flash 22/15

December 2015

I Near Miss: Corrosion-Related Failure of Bolts Used To Secure Lifeboat Winches

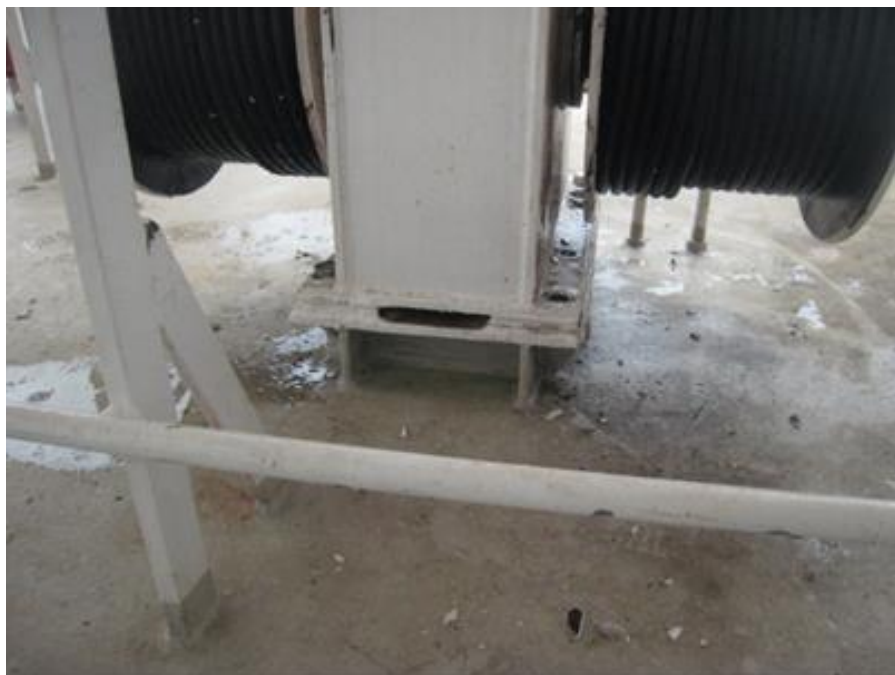
During a vessel inspection, a severed bolt was observed in the vicinity of a lifeboat winch foundation plate. It was quickly established that the failed bolt was one of eight bolts forming part of the assembly used to secure the lifeboat winch foundation plate to the deck.

There are four lifeboats on board the vessel, each with a similar winch and foundation arrangement. Further investigation of the first winch foundation plate detected an additional four bolts that were severed but still retained within the foundation assembly – in summary, a total of five out of eight bolts had failed. This prompted an inspection of all the winch foundation units on the remaining lifeboats. On a second lifeboat three out of eight bolts were detected as being severed while still being retained in place on the assembly by the paint coating. The remaining two lifeboat winch foundation assemblies were found to have no bolt failures.

Winch foundation plate assembly (with some failed bolts removed).

- ◆ A safety flash was issued to all company vessels instructing them to thoroughly examine similar lifeboat foundation plate hold down bolts;
- ◆ The vessel on which this incident took place, all foundation hold down bolts on all four lifeboat winch foundations were replaced;
- ◆ The severed bolts were taken onshore for metallurgical investigation to determine the root cause of the failure;
- ◆ The ship builder and the supplier of the lifeboats were notified of the incident and invited to participate in the investigation.

- ◆ All fleet vessels with similar winch foundation arrangements were to replace the existing bolts with grade 8.8 – Hot Dip Galvanized bolts and nuts as soon as possible;
- ◆ All fleet vessels with similar winch foundation arrangements were to ensure that the bolts are replaced every five years with grade 8.8 Hot Dip Galvanized bolts and nuts immediately before the 110% load testing of lifeboats. This will become part of the five-yearly lifeboat routine;
- ◆ Maintenance routines were revised to include the above changes;
- ◆ The ship builder was asked to investigate their own quality control procedures for nuts and bolts used in critical areas;
- ◆ The ship builder was asked to liaise with other ship owners for whom they had supplied similar davit foundation assemblies, to inform them of the situation and to ask them to check the condition of hold down bolts.

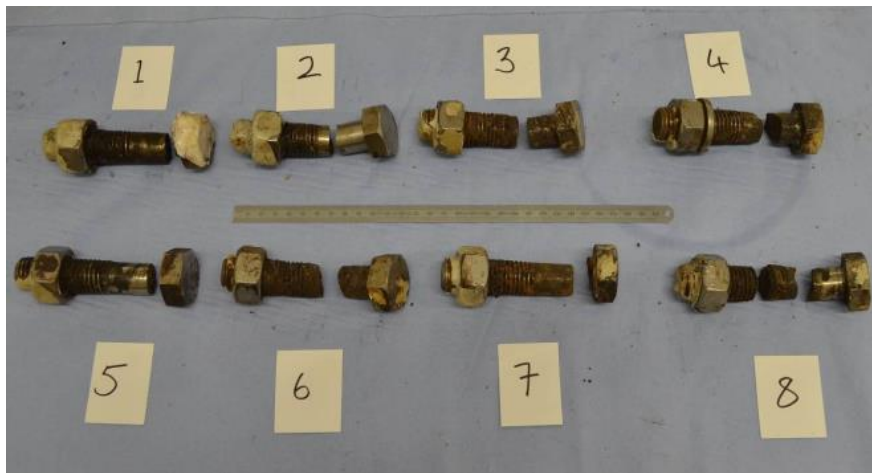
The condition of the severed bolts.

- ◆ The bolts failed as a consequence of intergranular corrosion;
- ◆ The chromium-manganese alloy from which these bolts were manufactured was not considered a suitable material for bolting in the marine environment;
- ◆ The carbon content of the alloy used would make the material highly susceptible to grain boundary sensitisation and consequently to intergranular corrosion.

In short, the bolts supplied and installed (which had been in place for approximately eight years) were not suitable for use and had failed through corrosion.

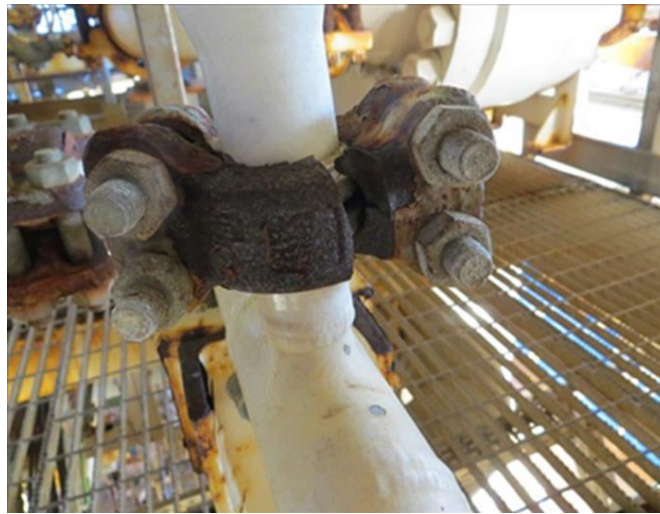
The UK Health and Safety Executive (HSE) has published a safety alert regarding an incident in which there was a catastrophic failure of a pipework clamp connector. The incident occurred on an offshore production platform where a 1" diameter Vector 'Techlok' pipework clamp connector catastrophically failed causing a gas release. The failure was caused by poor heat treatment during the manufacturing process, which led to failure by cracking.

Cracking caused by poor heat treatment during manufacturing process.

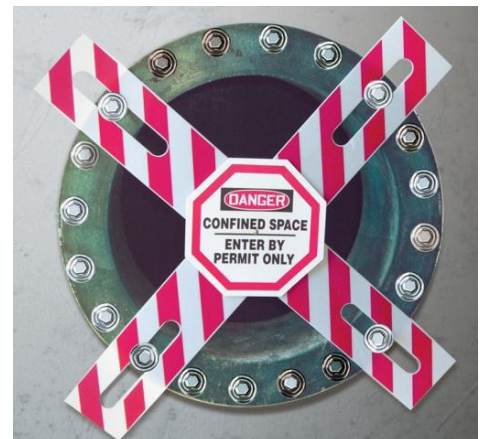
- ◆ Access to the confined space without informing a standby person;
- ◆ Confined space entry attendant observed a fire watch preparing a carbon dioxide fire extinguisher for the enclosed space;

- ◆ Electrical cable and oxygen / acetylene hoses approximately 15 cm from halogen light inside a confined space;
- ◆ Persons entering into the confined space without Permit to Work. They entered from another tank;
- ◆ Whilst performing tank sentry duties, one person was observed attempting to enter a confined space (a wing tank) without a personal gas detector;
- ◆ Third party contractor welder attempted to enter tank without wearing a harness;
- ◆ Near miss: confined space entry into fuel tank in breach of company integrated safe system of work - after observing smoke coming from open hatch.

- ◆ Care should be taken to ensure procedures are being followed and that all crew members remain situationally aware when potential risks are identified in an ever changing work environment;
- ◆ All personnel should remain vigilant with contractors on site during dry dockings and maintenance periods;
- ◆ In these cases, through the vigilant observations and intervention of the company vessel crew, the hazards were identified and controlled.
