ADAS SAFETY ALERT

Alert 2016/02

November 2016

Buoyancy Control Device (BCD) Maintenance

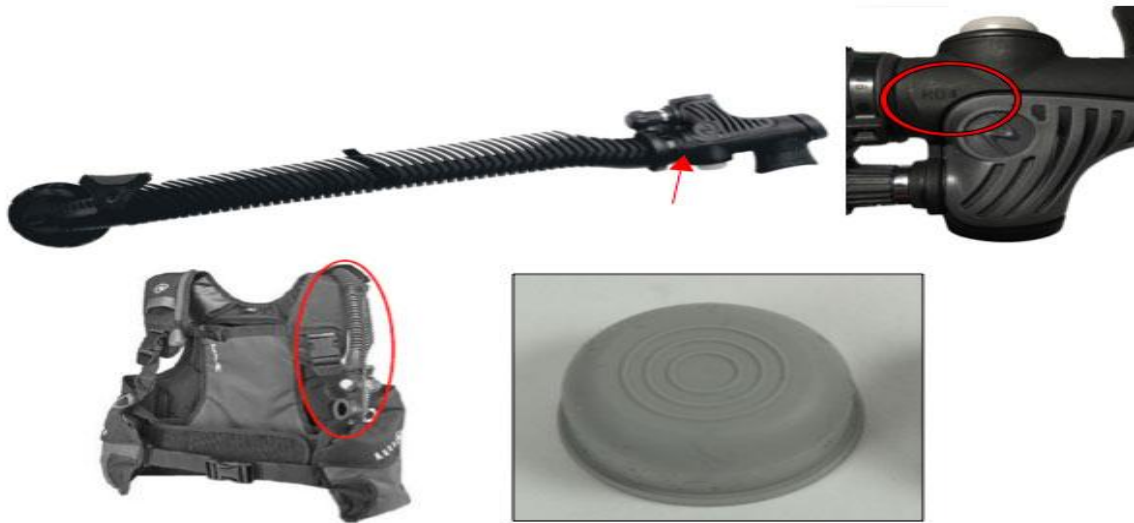
Of particular concern are Powerline inflators with a date code of “H”, as shown below.

Additionally, both Aqua Lung and Apeks Marine Equipment Ltd have issued a recall alert of select Powerline inflators, recommending that any Aqua Lung BCD purchased since January 1st 2015 is inspected by an authorised service provider, and replacements provided if required.
