IMCA Safety Flash 09/17

May 2017

Theme: Safety in Diving Operations

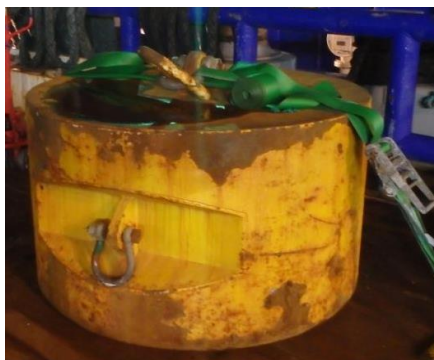
DMA as identified in procedures

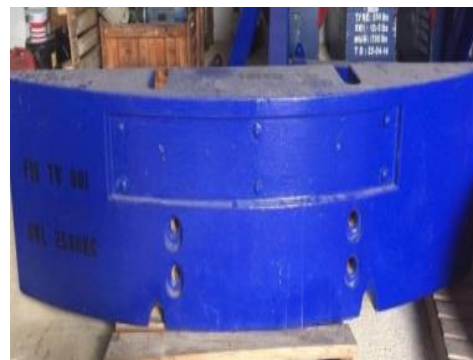
DMA3 that toppled over

- ◆ DMA3 that toppled over (blue DMA, right hand image) was different in weight and design from the one required in company procedures;
- ◆ DMA3 had a very narrow footprint and tall body with a high centre of gravity, making it unstable and unsuitable for rigging under tension and deploying in an upright position;
- ◆ The dive plan identified deployment of a 10te DMA (yellow DMA, left hand image). However, the team decided to use the one deployed by the 3rd party vessel;
- ◆ Whilst this was convenient, no check was made to ascertain whether or not it was fit for purpose;
- ◆ No management of change (MoC) process was initiated, and the risk of this DMA toppling was not identified.

- ◆ DMA3 was procured and sent offshore [by others] for another task. It was identified subsequently that DMA3 was in fact a crane counterweight and was not the most suitable piece of equipment for the task it was being used for;

- ◆ The lifting points on DMA3 were located on the top of the weight and it could only be deployed in the vertical position, offering a small footprint and high centre of gravity;

- ◆ DMA rigging to be altered to allow divers to be outside of the DMA footprint;
- ◆ Appropriate review of company documentation and procedures (to include DMA design specification and diver positioning) and also of the MoC process;
- ◆ Information sharing – video footage and details to be shared for training purposes.

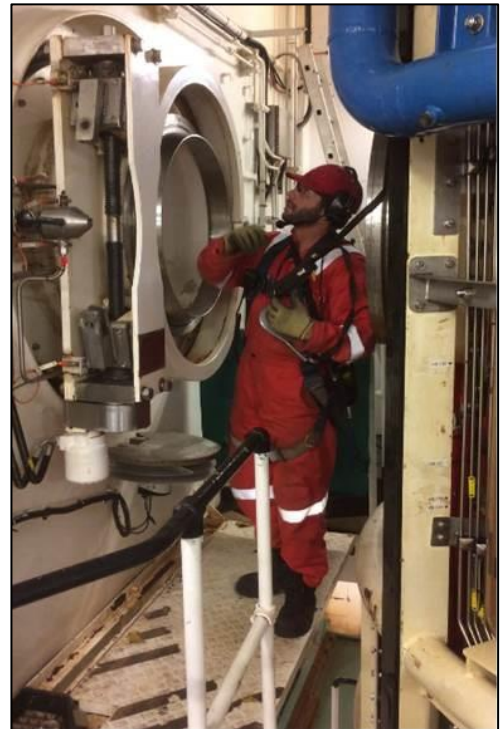
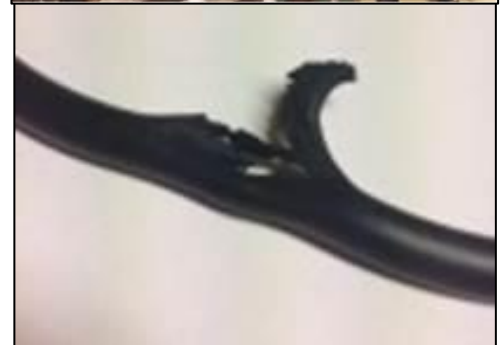
When the bell was trolleyed back and access platforms raised to access the sealing faces, the O ring seal was found to have been damaged. The O ring had become displaced prior to the bell mating, and a section of the O ring had come out of its groove. When the bell was mated, the O ring prevented the two faces from coming into correct alignment and the clamp would not close fully to allow the interlock to engage. During repeated clamp closures, the O ring was damaged but pushed back into the groove and until the clamp closed fully and the interlock engaged. The subsequent pressurisation procedure proved there was a leak past the O ring and the bell mating was ceased and the leak investigated.

The incident was caused by the damage to an O ring which had become misplaced. The O ring seal had not been fully inspected either by sight or touch before the bell lock off and reconnection, and this misplacement had not been identified.

- ◆ Lesson: Bell mating flanges and seals should be inspected between every bell run to ensure they are in correct location and in good condition;
- ◆ Actions taken:
 - a process is now in place requiring the inspection and recording of the bell mating flange faces and seals;
 - access has been improved to carry out this task without the need for specialist work methods and associated personal protective equipment (PPE).

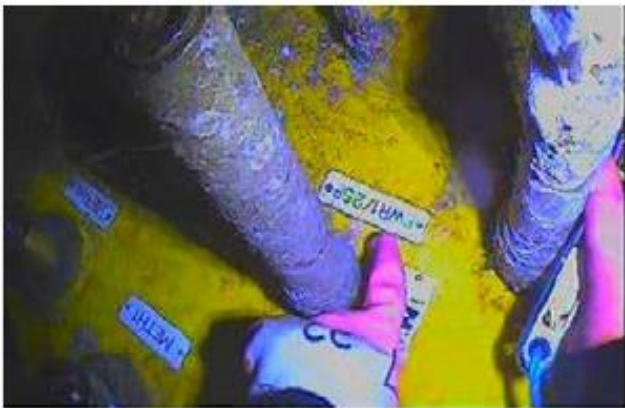
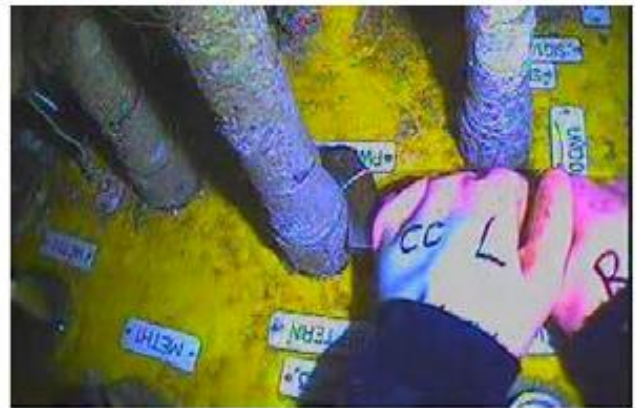
Initial attempt to remove correct Tronic unsuccessful

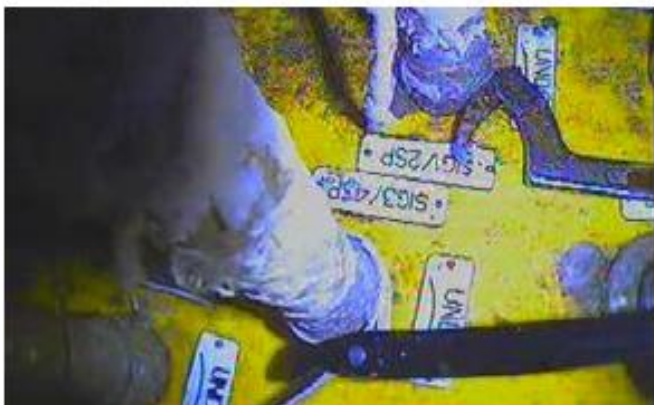
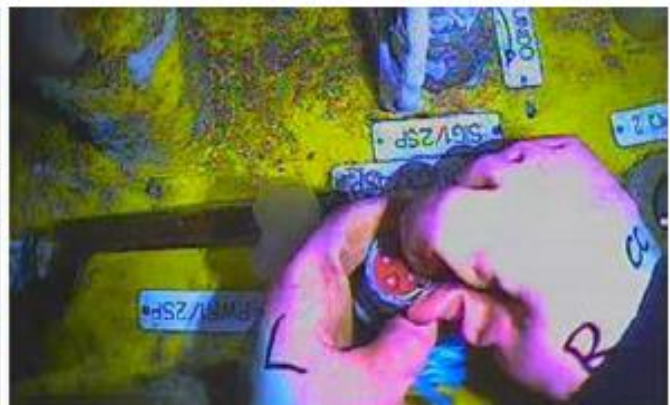
In order to provide more leverage, it was decided to try a strap wrench so the diver moved away from the worksite to collect this tool. Crucially, the C-spanner was left on a different but adjacent connector and when the diver returned with the strap wrench he mistook this connector for the one previously identified. The error went unnoticed and the diver removed and cleaned the wrong connector.

Incorrect Tronic removed and cleaned

- ◆ Increase focus/attention in setting up for worksite identification;
- ◆ Procedures and task plans should include steps to positively identify and mark the specific item to be worked on;
- ◆ Dive Supervisors should ensure the specific item to be worked on is positively identified and appropriately marked for intervention;
- ◆ Should the worksite be left, even momentarily, the item to be worked on should be reacquired and again positively identified before work resumes.

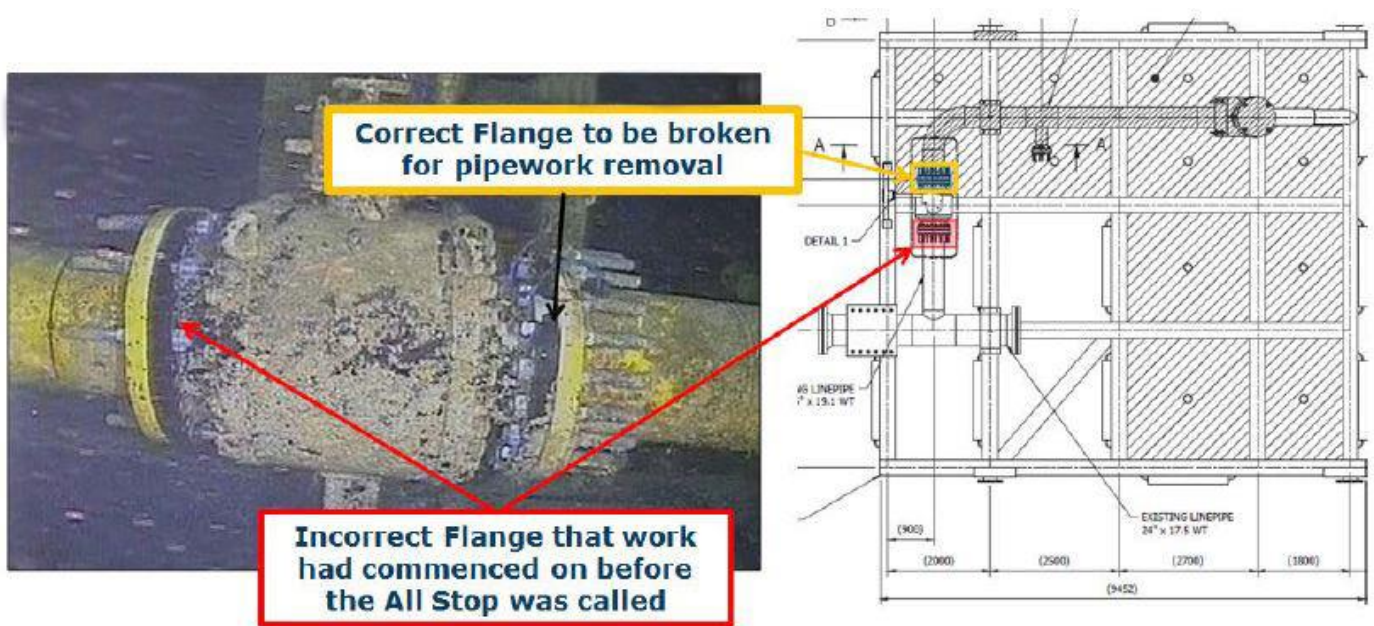
Planned operations for removal of a section of pipework from a flange took two dives. The section to be removed was correctly identified during Dive number 1, but after bell turnaround and the meal break, during Dive 2, the incorrect flange was identified and the wrong bolts were removed.

After several bolts had been removed, the Dive Supervisor called an “All Stop”, as it was identified that work was being conducted on the wrong flange. A “Time Out for Safety” was called to discuss actions already taken and to agree the further actions needed. At no time were the divers or equipment at risk as the Pipeline End Manifold was shut down.

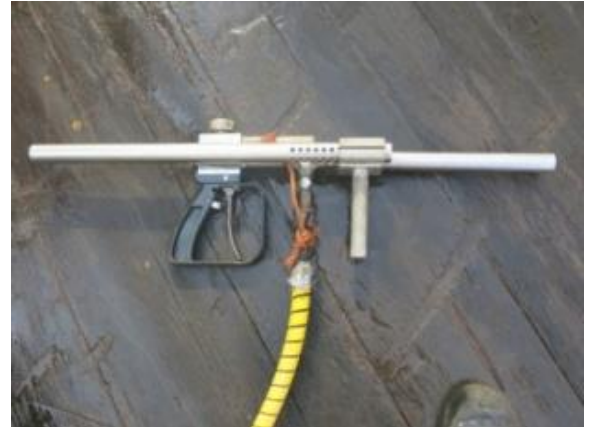
During diving operations to clean a riser with a HP water jet type *Cavitek*, a diver cut his leg (thigh) with the water jet.

The incident occurred whilst the diver was not properly secured during the cleaning operation. The diver should always be comfortably and securely positioned during HP water jetting operations. It is especially important to ensure that this is so during mid-water work, otherwise there is a greater likelihood that the diver may lose control of the trajectory of the jet stream during jetting operations. The likelihood of such an event will also be increased if the retro jet and forward jet on the gun is strongly unbalanced.

Our member notes that there was an incorrect calculation of the HP hose length needed for this job. The minimum length of hose required per jetting gun unit is normally considered to be 1.5 times the maximum anticipated working depth. The length of the hose should not impact upon the comfort and security of the diver during HP water jetting operations.

The length of the waterjet lance may not have been appropriate (too short). The inherent potential for accidental self-injury during use of high pressure jetting guns increases as the length of lance (barrel) decreases.

- ◆ Before water jetting operations:
 - ensure proper and dedicated tool box talks are held
 - ensure there is a full assessment of risks and needs at the work area
 - check the required length of hose;
- ◆ When cleaning vertical parts of structures in mid-water divers should be rigged to be stable and comfortable for jetting operations;
- ◆ Check that the gun is appropriately designed, properly balanced, well-maintained and fit for purpose;
- ◆ Ensure the diver holds the gun with two (2) hands;
- ◆ Stop/release the trigger before each movement.
- ◆ Ensure regular communication from the diver to the dive supervisor about the situation at depth;
- ◆ Remind the dive team of the importance of good communications and **consistent observance of safe working practices**.

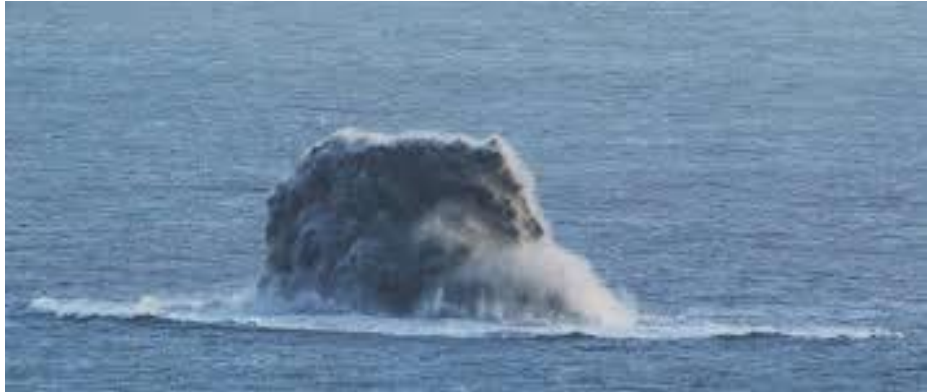
A member has reported a near miss incident in which there was an unplanned release of gas from a subsea pipeline, when divers were working nearby. A vessel was engaged in connecting a 32" (81cm) spool to the pipeline with the vessel crane connected to the spool. Divers were in the bell for changeover of shift. Suddenly there was a release of gas near to the vessel. The Master took immediate action and moved the vessel 150m out of the area; the clearing crane wire was slacked off, and at a safe distance when no bubbles were observed in the water, the ROV was launched. The ROV went to the crane hook location, and the crane hook was released safely. ROV and crane wire was recovered without any damage to any property. The divers were unharmed.

- ◆ An energy isolation permit was in place which was issued by the refinery and platform;
- ◆ The refinery failed to inform the vessel about the valve opening and expected gas flow down the pipeline.

- ◆ There should be proper communication established between the refinery and the vessel before opening any valves and permitting gas flow down the pipeline;
- ◆ The vessel should be ready always to face any H₂S emergency at site;
- ◆ Drills for H₂S emergency, general muster, abandon ship and LARS bell recovery should be carried out regularly;
- ◆ H₂S detectors and appropriate PPE should be tested periodically.
