Updated - Technical Service Bulletin

SUBJECT: REMEDIAL PROCEDURE TO ADDRESS POSSIBLE OXYGEN LEAKS FROM CONTROL VALVES

BULLETIN NO.: TSB 2018-01 (Revised)

AFFECTED MODEL(S): **BR22 PLUS** EXOTHERMIC CUTTING TORCH

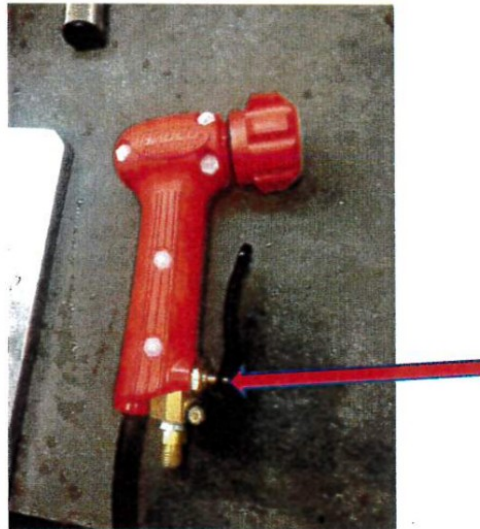
- The picture below shows what a BR22 PLUS torch looks like and the location of the valve stem leak. If this is not what your torch looks like, do not continue!

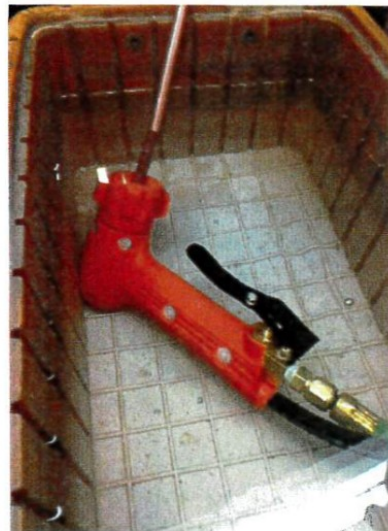
- Outfit the BR22 PLUS torch as shown with an 18" cutting rod inserted and the collet tightened.

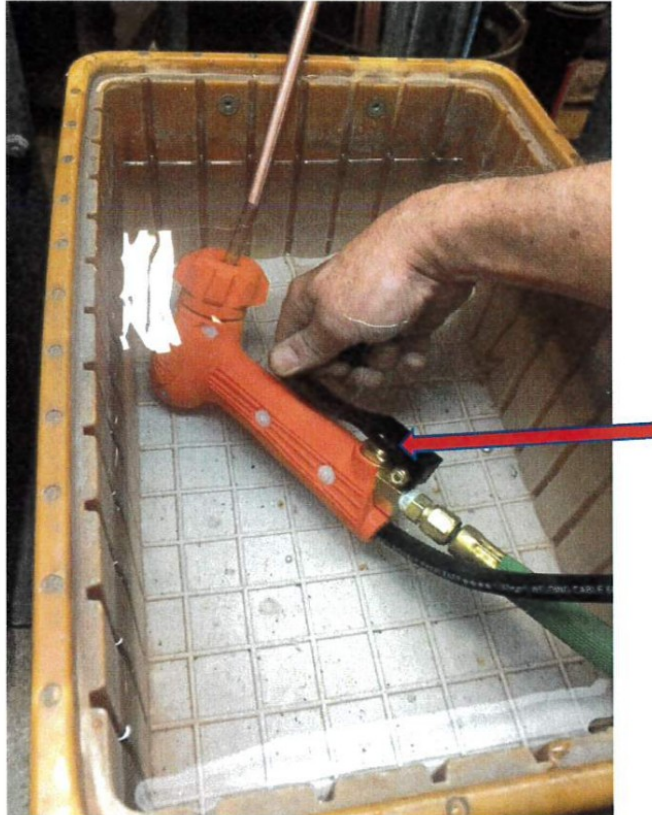
- Set oxygen pressure to 180psi (double that of normal operating pressure) and submerge the entire BR22 PLUS torch under water in a suitable container of your choice with the end of the cutting rod raised above the water to exhaust the oxygen gas. Be sure that the valve section is submerged at least 2" below the water surface for clear detection of any possible oxygen leaks.
- Keep the BR22 PLUS submerged for about 30 seconds before carrying out the next steps. You will likely see some bubbles here from air pockets inside the torch body.
- With the end of the rod raised above water, depress the valve lever with a 2 second count and while doing so, inspect the valve stem area (shown in the picture with a red arrow) for any steady stream of bubbles. Repeat this step 5-10 times.

- If the stream of bubbles is present, please remove the BR22 PLUS torch from service and contact Broco-Rankin. If there are no visible leaks, please resume use of the product as intended.
